Honeywell Report, Figure 124

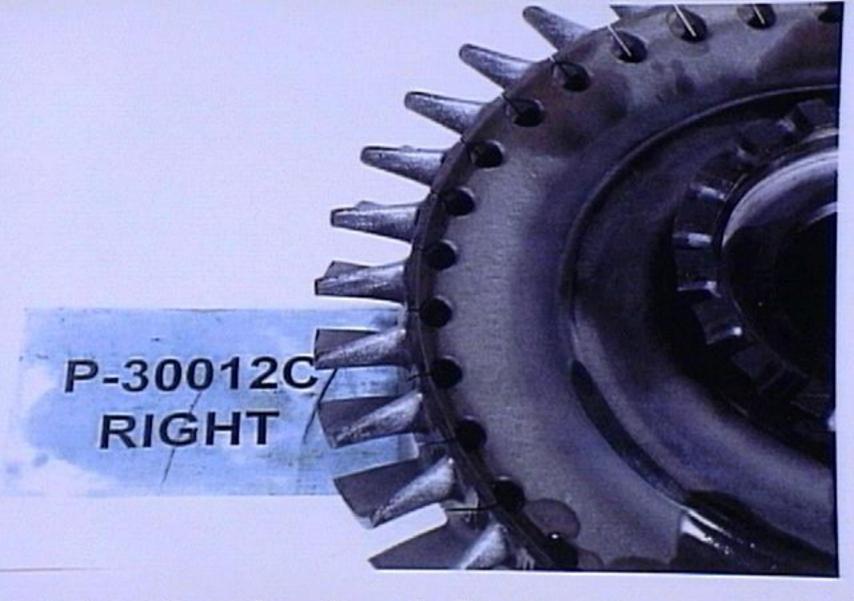
124. Metal Spray Deposits on the First-Stage Turbine Blades
